c-Si 太陽電池セル裏面の腐食劣化態様

棚橋 紀悟¹・坂本 憲彦²・柴田 肇³・増田 淳¹

産業技術総合研究所 ¹太陽光発電研究センター、²計量標準総合センター

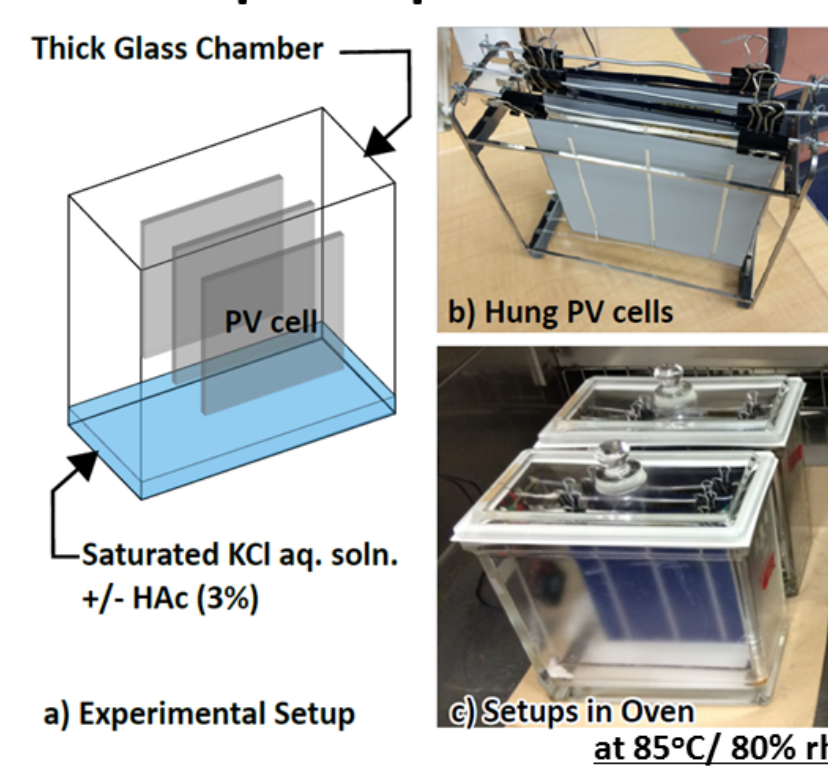
Background (1) (HAc = Acetic Acid) Corrosion in Alumina Paste Layer (APL) 25 °C / 45% rh, 2 months 25 °C / 85% rh, 240 h 25 °C / 85% rh, 240 h with HAc Atmosphere H. Xiong et al., "Corrosion behavior of crystalline silicon solar cells," <i>Microelectron. Reliab.</i> , vol. 70, pp. 49-58, Mar. 2017.	Background (2) (HAc = Acetic Acid) Proposed Corrosion Models Front Side Rear Side H. Xiong et al., "Corrosion behavior of crystalline silicon solar cells," <i>Microelectron. Reliab.</i> , vol. 70, pp. 49-58, Mar. 2017.	Experimental (1) (HAc = Acetic Acid) HAc-Vapor Exposure of Bare PV Cells

Whole planes of both surfaces in a testing PV cell are uniformly surrounded by the applied stressors (temperature, humidity, and HAc vapor). → Spatiotemporally harmonized power-loss and R_s -elevation are supposed to be observed in the testing PV cell. T. Tanahashi, N. Sakamoto, H. Shibata, and A. Masuda, "Localization and characterization of a degraded site in crystalline silicon photovoltaic cells exposed to acetic acid vapor," <i>IEEE J. Photovolt.</i> , vol. 8, no. 4, pp. 997-1004, Jul. 2018.	Experimental (2) Localization of Series Resistance (R_1)

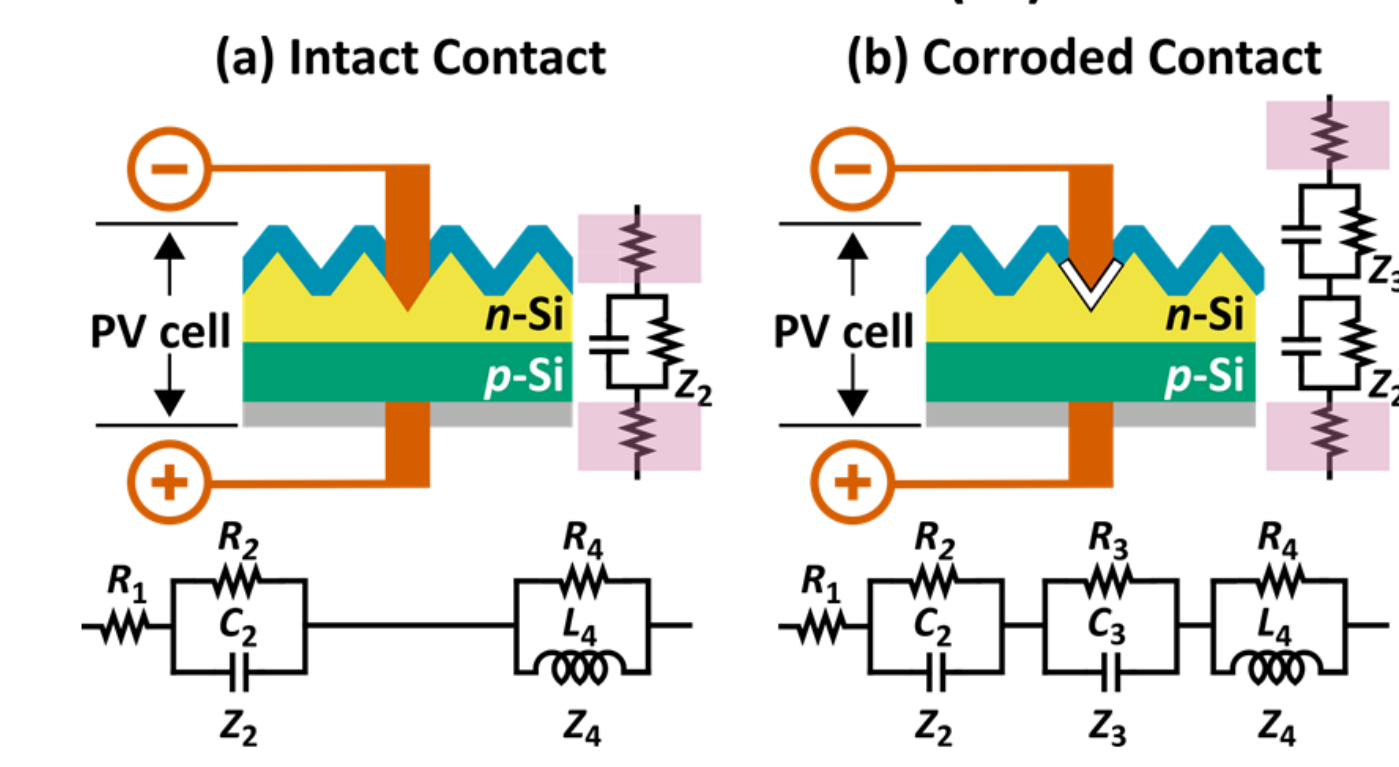
(a) Intact Contact (b) Corroded Contact PV cell PV cell with the respective AC equivalent circuits (under dark conditions). Rectangles colored in pink indicate the assumed locations of R_1 .

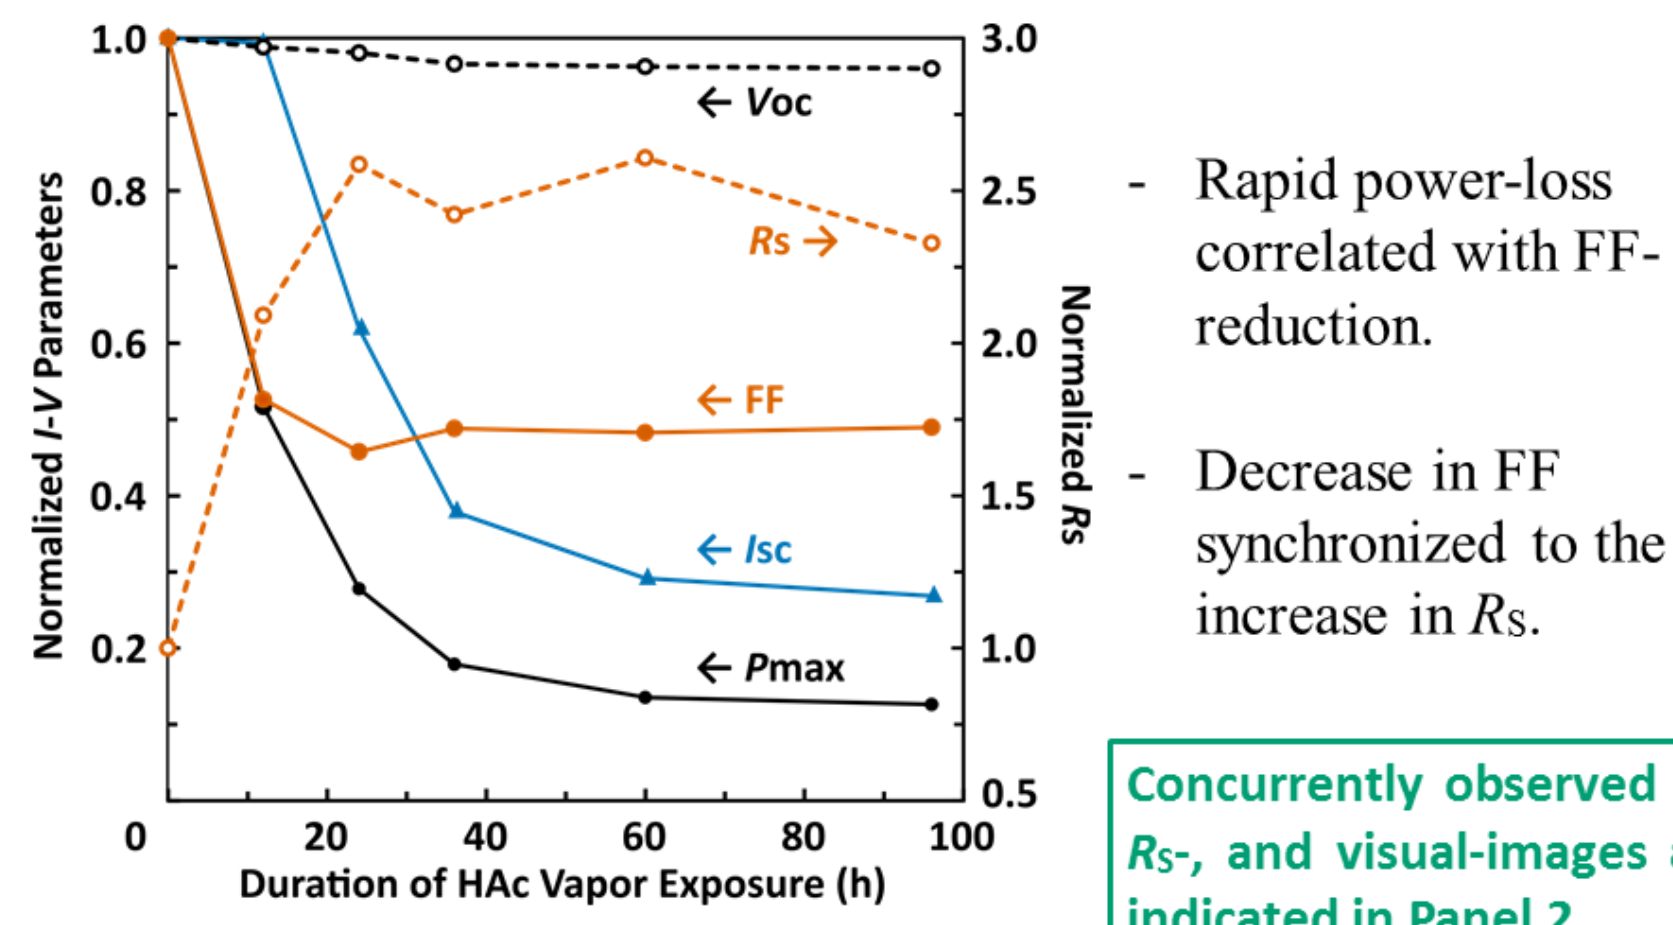
Panel 1: Degradation Behavior

Degradation Profiles of a PV Cell Exposed to HAc Vapor

R_s is estimated from I-V data obtained in the dark. Both vertical axes indicate I-V parameters normalized by their initial values.

Concurrently observed EL-, R_s -, and visual-images are indicated in Panel 2.

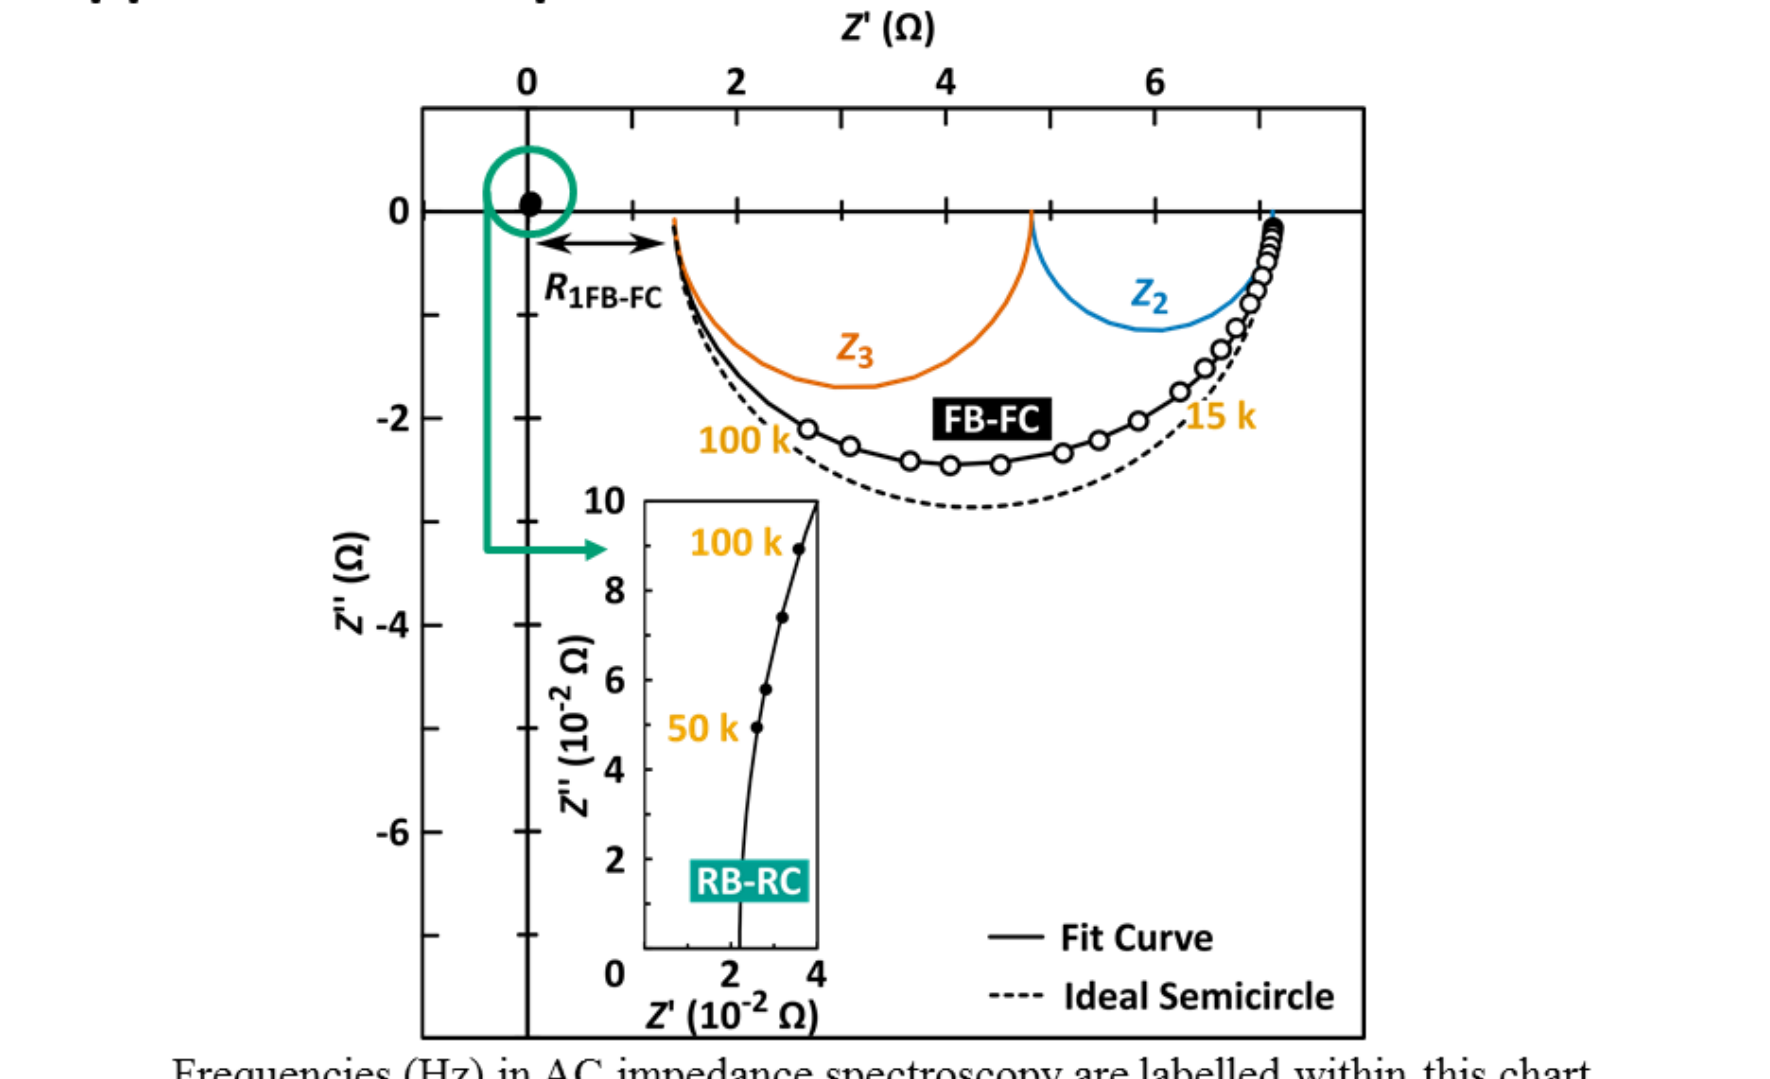
Panel 9: Identification of R_1 -Origin

Appendix: AC Impedance Loci of FB-FC and RB-RC Contacts
